# Canopy Walk

By Spence Rosenfeld, RCA #332  
President, Arboguard Tree Specialists

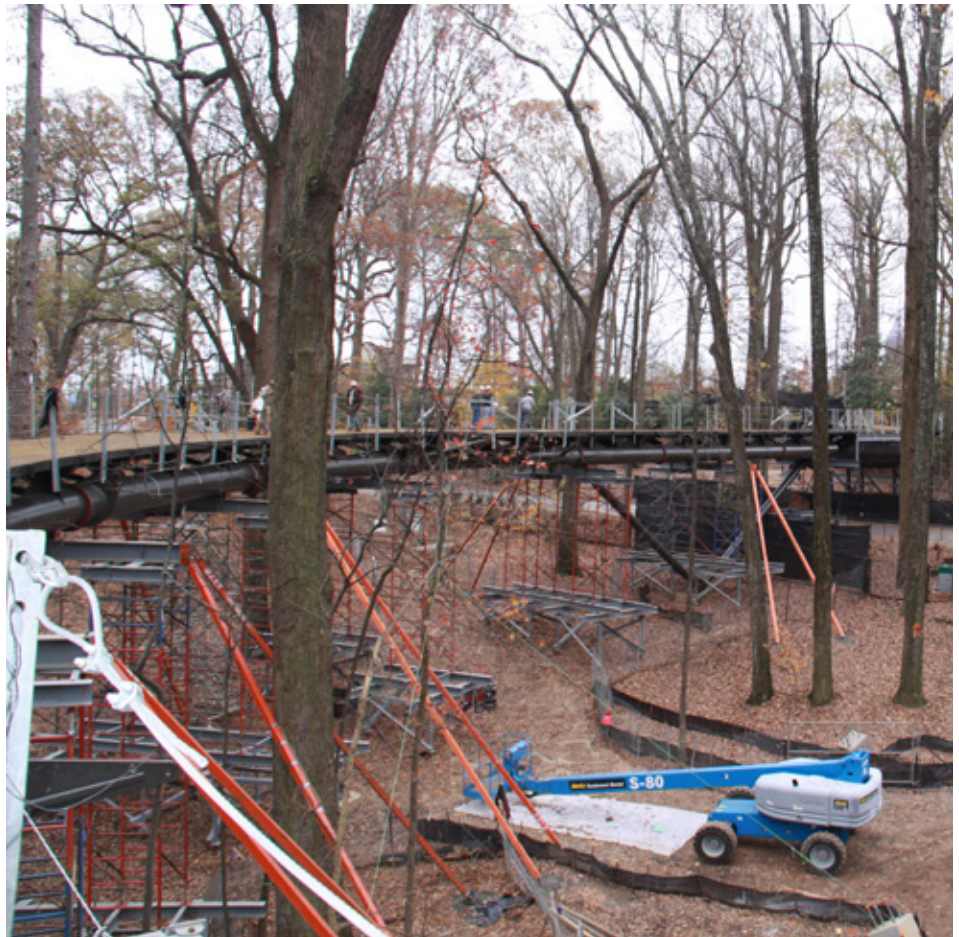
**Piers and Helical Anchors (far shot):** Providing ground support for temporary walkway scaffolding.

- Temporary access roads were located and built using suspended timbers and AlturnaMats®, to disperse weight from materials and 40-ton cranes moving within the root zones. Movement was contained within tight corridors lined with thousands of feet of 6’ tall chain-link tree protection fence.
- Original plans called for massive 16’x16’ wide concrete slabs to anchor the masts that held up the structure and backstays. After lengthy discussion, these were re-engineered to use an alternative method of support. Final anchoring was completed using drilled 7” wide micropiles instead of massive slabs, which reduced impact for anchoring by over 99%.
- To hold the walkway in place before the final suspension cables were installed,

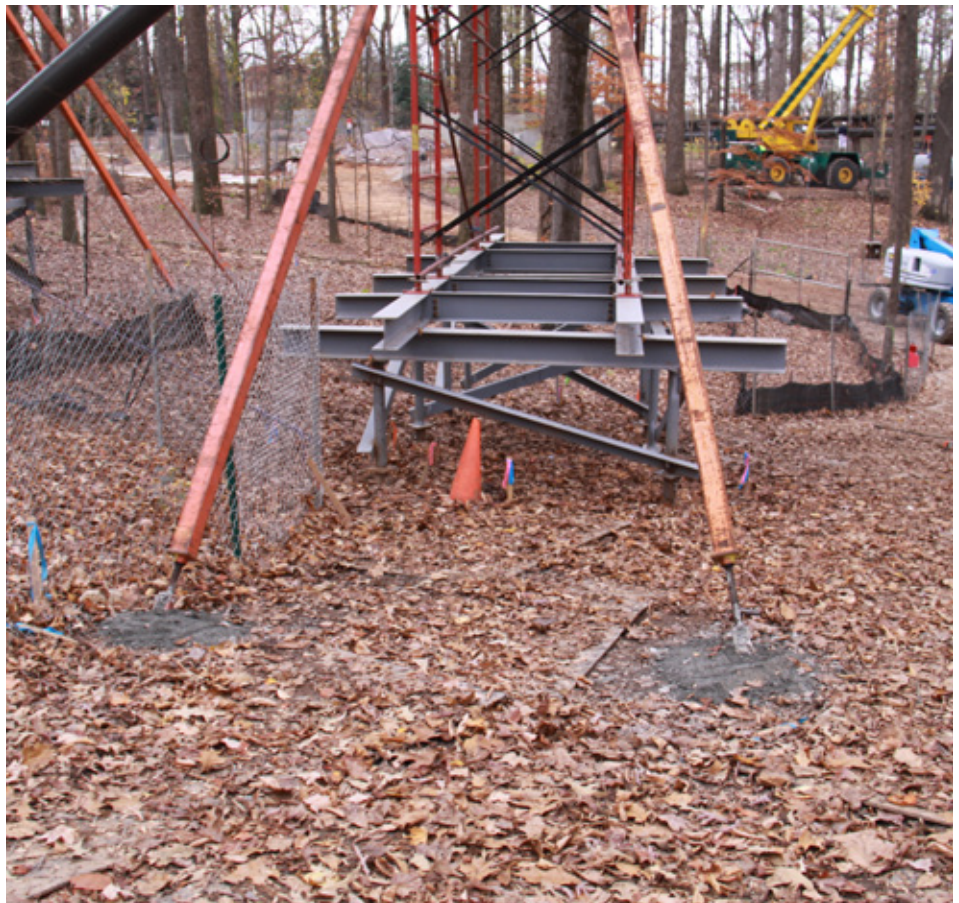
**Piers and Helical Anchors (close shot):** Providing ground support for temporary walkway scaffolding.

a scaffold system made up of 16 scaffold towers was necessary. Originally, these were to be built on graded slabs to provide a flat base, which required extensive grading. Instead, they were installed using helical anchors to straddle roots, reducing the impact by over 98% in these areas. To further reduce root loss during the installation of the helical anchors, an Air-Spade® was utilized to blow soil off areas where anchors were needed. Once tree roots were exposed, it was then possible to hand thread anchors through the root system.

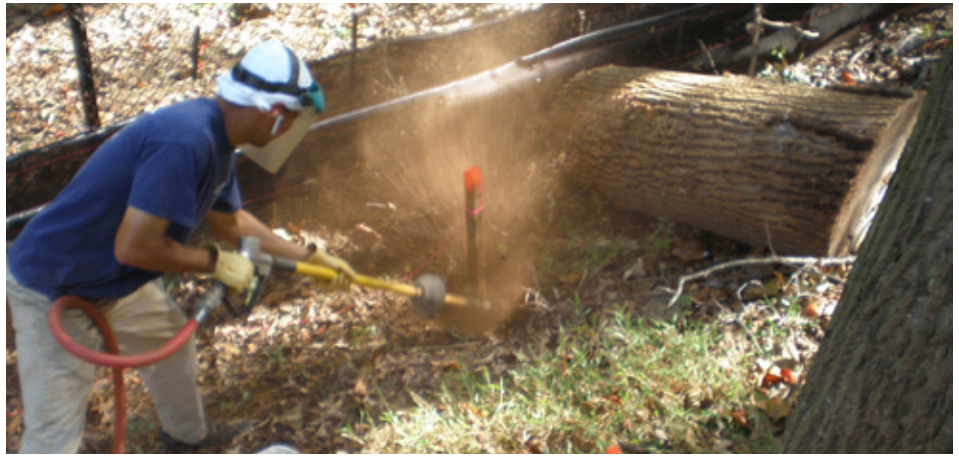
**Air-Spade® for helical anchor 1:**  
Blowing soil off root system prior to helical anchor insertion.

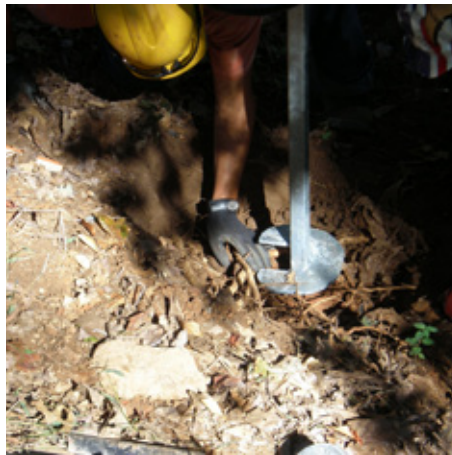
**Left: Air-Spade® for helical anchor 2:**  
Threading helical anchor through exposed roots.

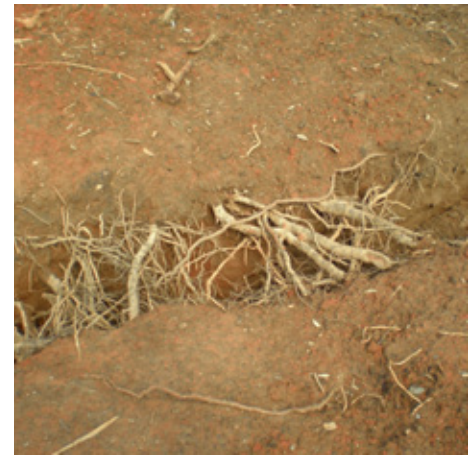
**Right: Air-Spade® for utility lines:**  
Blowing soil off root system to thread utility lines underneath.

- Instead of traditional utility line installation, where a backhoe would be used to trench through roots, an Air-Spade® was used to excavate around and below dense root mats so utility lines could be threaded below the roots. Air-Spade® excavation was used for the main electric line and substation connections, as well as most irrigation main lines.
- Subsurface drain lines were replaced with dry, hand-laid creek beds and surface flumes that became attractive visual features, adding to the interest and beauty of the gardens. In one case, a 14' deep by 12" wide drain line, which would have cost over \$100K, was eliminated and replaced with a much less expensive surface flume, while preserving 7 massive native Poplars.

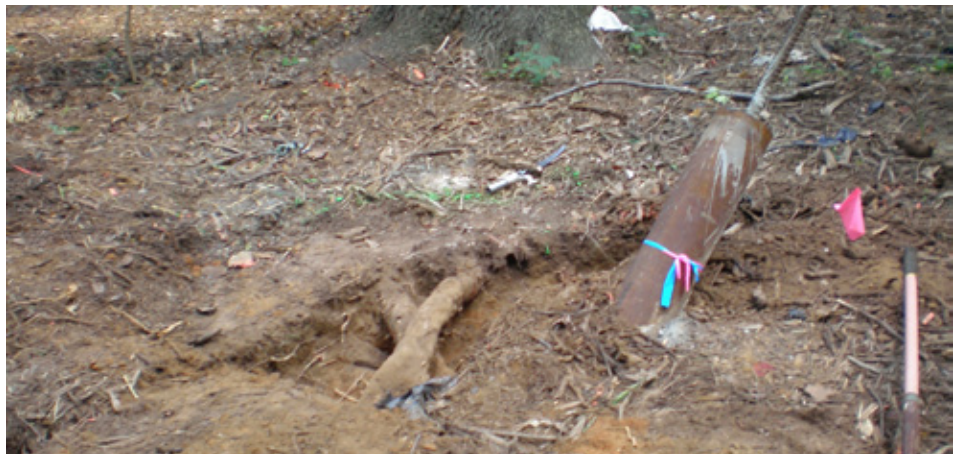
**Micropiles (before):** Eliminating 12'x12' underground concrete slab.

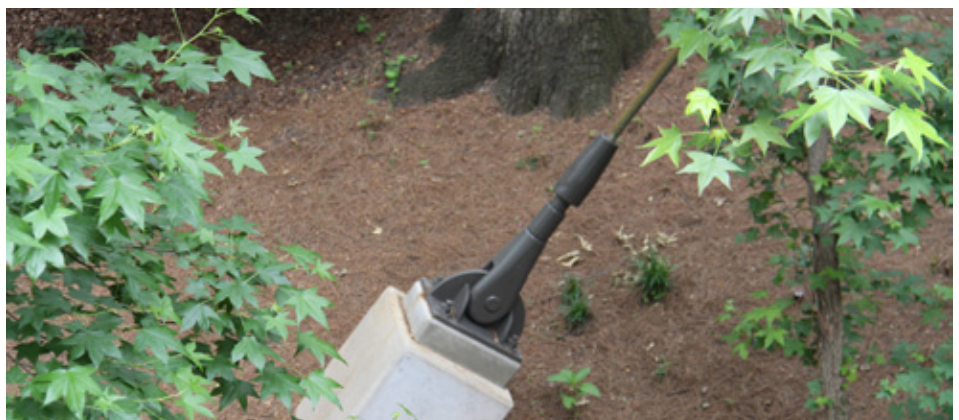
**Micropiles (after):** Completed micropile anchor.

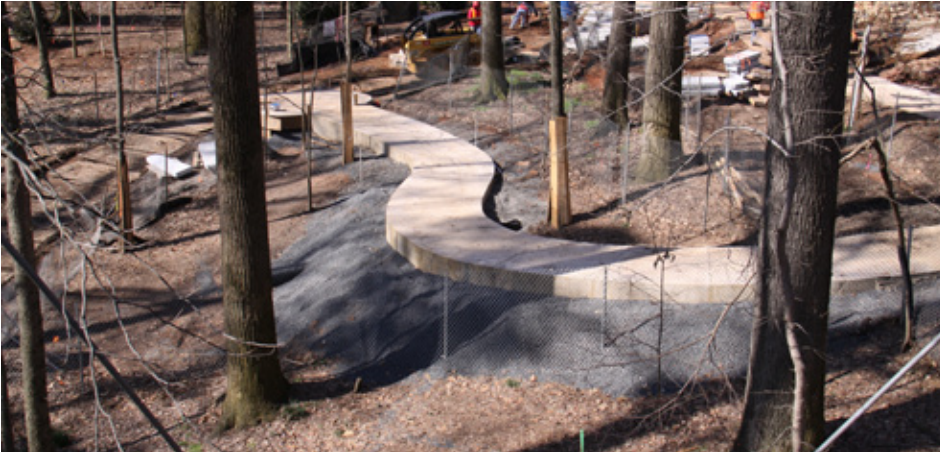
**Root Bridging (before):** Constructing walkways above-ground.

- Numerous retaining walls were designed to support surface sidewalks, allowing access deep into the woods. To replace traditional wall installation requiring extensive footings and root damage, all walkway construction was done above grade. This process, known as “root bridging,” involved laying geotextile fabric on grade and adding layers of expanded slate aggregate on top, forming a solid sub-base on top of which sidewalks were built. In some cases the sidewalks were “stapled” to the ground using long helical anchors to stabilize them, as an alternative to retaining walls with footings.
- A comprehensive Soil Therapy and Tree Health Care Program was implemented utilizing a battery of organic soil amendments and root stimulants to improve tree vitality and stimulate root regeneration.

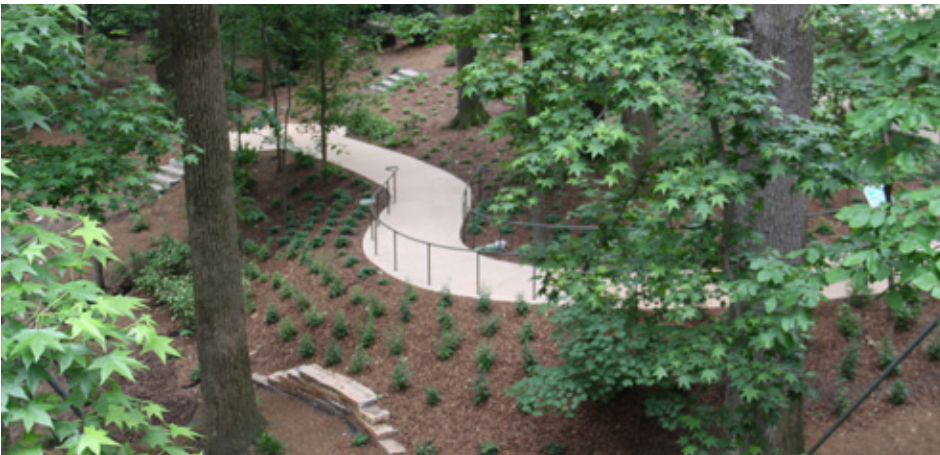
**Root Bridging (after):** Completed above-ground walkway.
